**Flood Control Project Maintenance
Levee Inspections**

Maintenance Issue Types Only, Levee Inspection Report By Mile - Fall 2016

Levee District No. 0001 (Glenn County)

Waterway	Bank	Unit Miles	Inspection Start/End	Inspector
Unit No. 01 Sacramento River	Right	12.23	09/16/2016 09/16/2016	Tariq Chechi

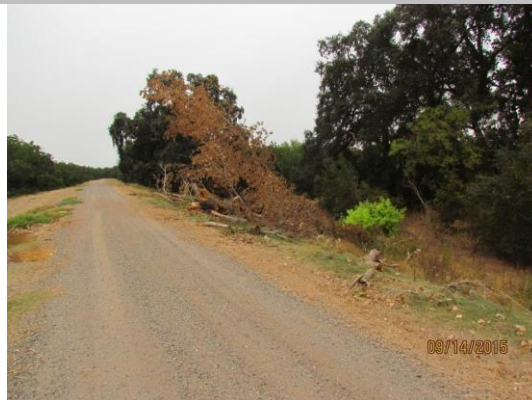
Photo 1 of 2 : FA_2016_LD0001G_432_41_20160823_00012.jpg

LM Start	0.25	Rating **	M	Issue No.	41
LM End	0.25	Issue Type +	Ma	Location *	WS
Category	Earthen Levee			GPS Latitude/Longitude	
				Start	End
Item	Encroachments			39.480769 °	39.480769 °
				-122.017301 °	-122.017301 °
DWR ID	DWR_LD0001G_01_f_2015_41				
Comment Code					
TR : Tree or limb					
Inspector Comment					
Remove tree from the waterside slope.

View of the tree on the waterside slope.

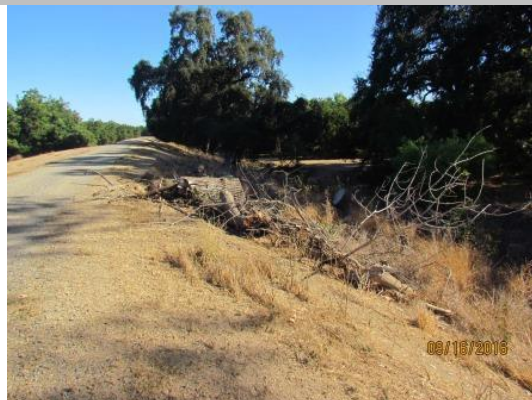
Photo 2 of 2 : FA_2016_LD0001G_432_41_20160922_00092.jpg

LM Start	0.25	Rating **	M	Issue No.	41 (cont)
LM End	0.25	Issue Type +	Ma	Location *	WS

View of the fallen tree on the waterside slope looking upstream.

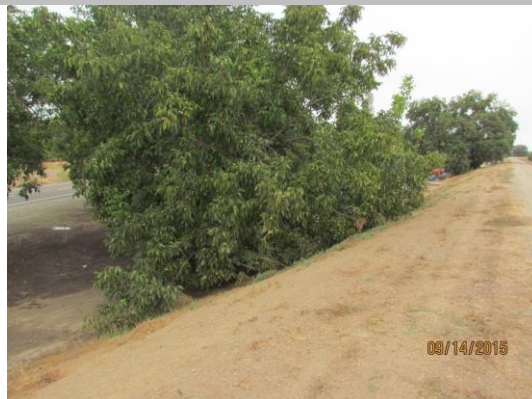
Photo 1 of 1 : FA_2016_LD0001G_432_43_20160823_00013.jpg

LM Start	1.01	Rating **	M	Issue No.	43
LM End	1.01	Issue Type +	Ma	Location *	WS
Category	Earthen Levee			GPS Latitude/Longitude	
				Start	End
Item	Trim / Thin Trees			39.490963 °	39.490963 °
				-122.020510 °	-122.020510 °
DWR ID	DWR_LD0001G_01_f_2016_43				
Comment Code					
T1 : Trim trees to at least five feet above ground level.					
Inspector Comment

View of the tree limbs on the landside slope.

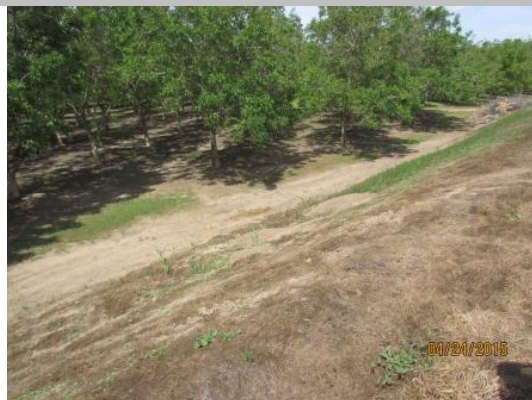
Photo 1 of 2 : FA_2016_LD0001G_432_59_20160823_00027.jpg

LM Start	1.22	Rating **	M	Issue No.	59
LM End	1.22	Issue Type +	Ma	Location *	LS
Category	Earthen Levee			GPS Latitude/Longitude	
				Start	End
Item	Animal Control			39.493667 °	39.493667 °
				-122.018643 °	-122.018643 °
DWR ID	DWR_LD0001G_01_f_2015_59				
Comment Code					
A3 : No rodents visible, but rodent burrows visible; need to backfill and compact or grout burrows.					
Inspector Comment					
The levee district has a rodent program in place.

View of the rodent holes along the landside slope.

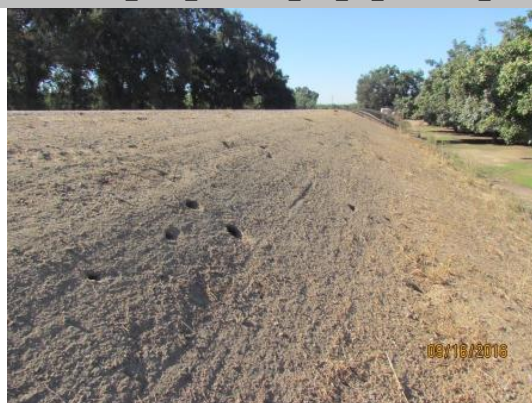
Photo 2 of 2 : FA_2016_LD0001G_432_59_20160922_00094.jpg

LM Start	1.22	Rating **	M	Issue No.	59 (cont)
LM End	1.22	Issue Type +	Ma	Location *	LS

View of the rodent holes along the landside slope.

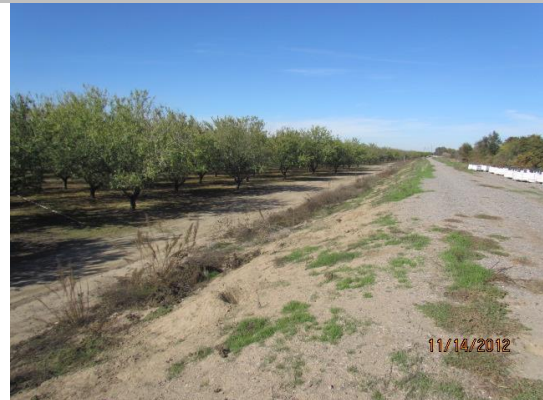
Photo 1 of 1 : FA_2016_LD0001G_432_7_20160823_00004.jpg

LM Start	5.08	Rating **	U	Issue No.	7
LM End	5.17	Issue Type +	Ma	Location *	LS
Category	Earthen Levee			GPS Latitude/Longitude	
				Start	End
Item	Animal Control			39.534741 °	39.536013 °
				-121.996024 °	-121.996702 °
DWR ID	DWR_LD0001G_01_f_2012_7				
Comment Code					
A3 : No rodents visible, but rodent burrows visible; need to backfill and compact or grout burrows.					
Inspector Comment

View of the rodent hole along the levee slope.

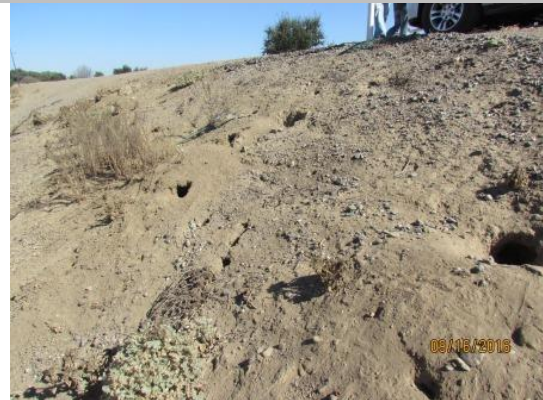
Photo 1 of 1 : FA_2016_LD0001G_432_67_20160922_00096.jpg

LM Start	5.22	Rating **	U	Issue No.	67
LM End	5.22	Issue Type +	Ma	Location *	LS
Category	Earthen Levee			GPS Latitude/Longitude	
				Start	End
Item	Animal Control			39.536750 °	39.536750 °
				-121.997090 °	-121.997090 °
DWR ID	DWR_LD0001G_01_s_2016_67				
Comment Code					
A1 : Exterminate rodents and backfill and compact or grout burrows.					
Inspector Comment					
Rodent holes on the LS slope need to be backfilled.

View of the rodent holes along the landside slope.

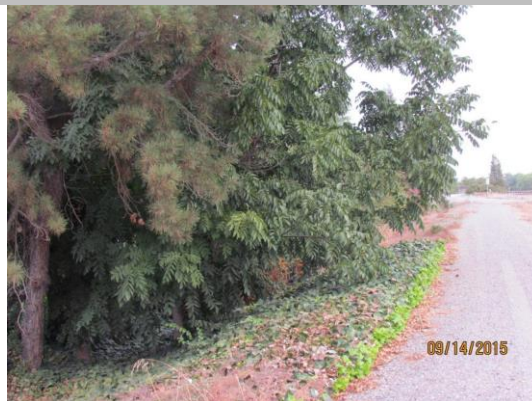
Photo 1 of 1 : FA_2016_LD0001G_432_64_20160823_00032.jpg

LM Start	6.30	Rating **	M	Issue No.	64
LM End	6.30	Issue Type +	Ma	Location *	LS
Category	Earthen Levee			GPS Latitude/Longitude	
				Start	End
Item	Trim / Thin Trees			39.551666 °	39.551666 °
				-122.002639 °	-122.002639 °
DWR ID	DWR_LD0001G_01_f_2015_64				
Comment Code					
T1 : Trim trees to at least five feet above ground level.					
Inspector Comment					
Trim trees along the landside slope.

View of the trees along the landside toe.

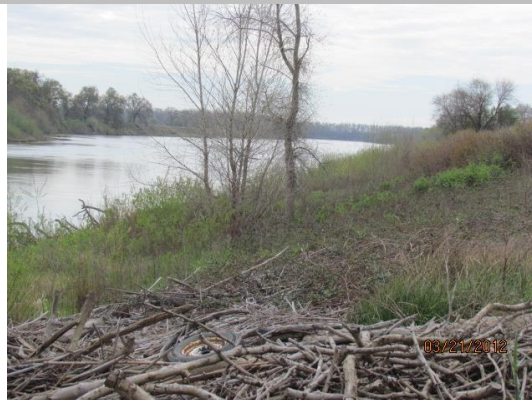
Photo 1 of 1 : FA_2016_LD0001G_432_10_20160823_00006.jpg

LM Start	6.38	Rating **	A/W	Issue No.	10
LM End	6.64	Issue Type +	Ma	Location *	WS
Category	Earthen Levee			GPS Latitude/Longitude	
				Start	End
Item	Vegetation			39.552691 °	39.556459 °
				-122.003063 °	-122.003831 °
DWR ID	DWR_LD0001G_01_s_2012_10				
Comment Code					
V8 : Environmental Requirements.					
Inspector Comment

View of the Army Corps of Engineers mitigation site.

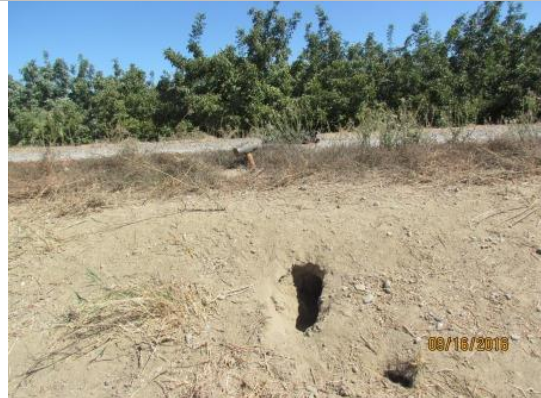
Photo 1 of 2 : FA_2016_LD0001G_432_79_20161003_00100.jpg

LM Start	11.66	Rating **	U	Issue No.	79
LM End	11.66	Issue Type +	Ma	Location *	LS
Category	Earthen Levee			GPS Latitude/Longitude	
				Start	End
Item	Animal Control			39.624112°	39.624112°
				-121.999933°	-121.999933°
DWR ID	DWR_LD0001G_01_f _ 2016_79				
Comment Code					
A1 : Exterminate rodents and backfill and compact or grout burrows.					
Inspector Comment					
Rodent holes on the landside slope and crown.

View of the rodent holes along the landside slope with large hammer sitting in the hole.

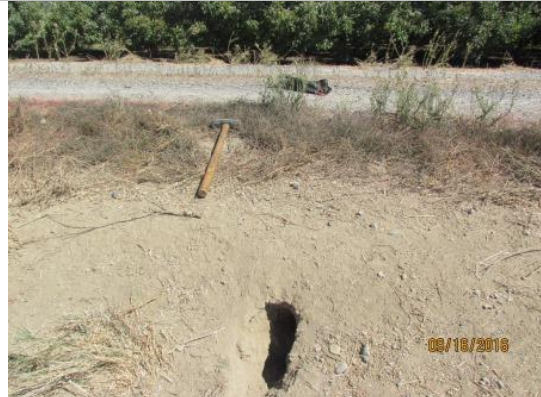
Photo 2 of 2 : FA_2016_LD0001G_432_79_20161003_00101.jpg

Another view of the rodent holes along the landside slope with a large hammer sitting next to the hole.
